# Manhole Inspection Summary

Manhole # S35AA1016MH

**Location** Address: **305 SOUTHWAY**

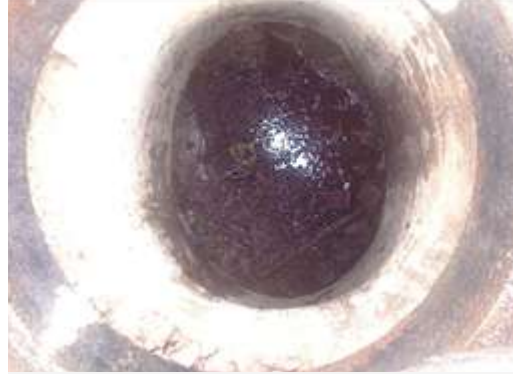
Top View

Missing steps. Channel debris.

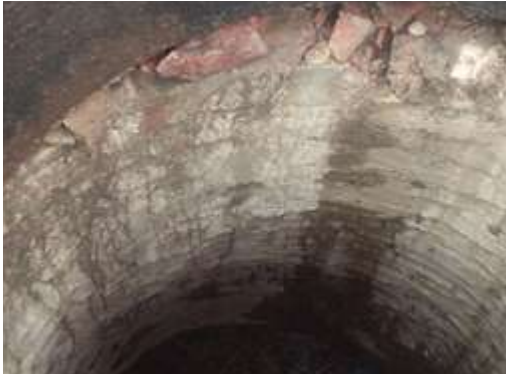
Defect

Frame leaks. Adjustment deterioration, loose brick and infiltration. Corbel and Barrel infiltration.

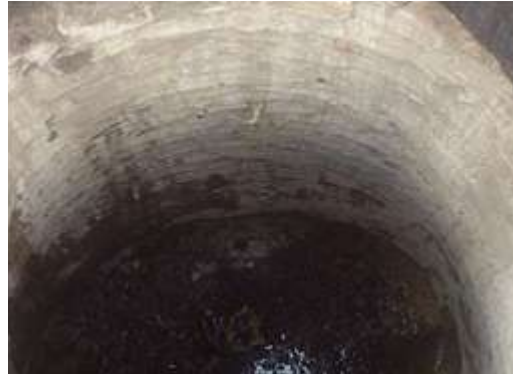
Defect

Adjustment and Barrel infiltration. Corroded and missing steps.

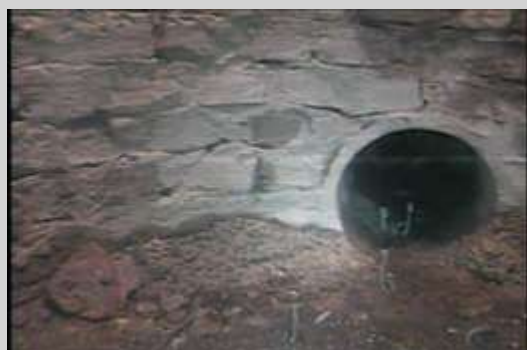
Pipe Out @ 12 O'Clock

Barrel deterioration and infiltration.
